Date: June 03, 2025

**Urgent: Medical Device Correction UPDATE**  
**Dexcom G6 Receiver – MT27408-1, Dexcom G7 Receiver – MT26403-0**

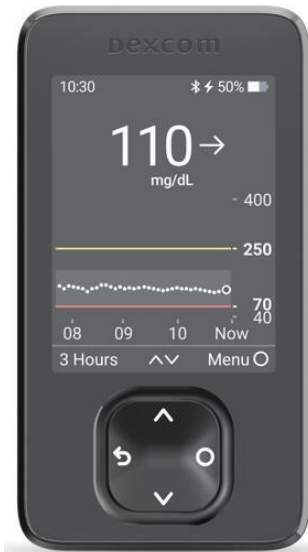
**Front of Receiver**  
Example Rendering:

**Image 4:** Examples of Affected Receiver

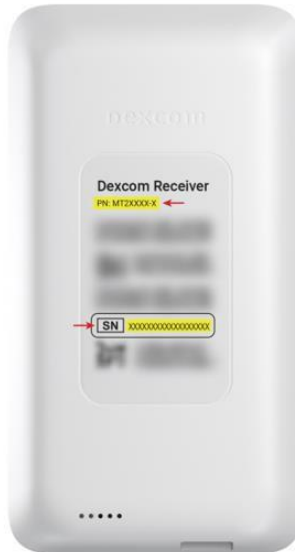
**Back of Receiver**  
Example Rendering:

- Note: The part number and serial number are both listed on the back of the receiver as shown in the image to the right/below):

- Verify if your receiver is affected by this issue: Check the serial number for any receiver(s) you use, with a part number listed in Table 1, by visiting this webpage:  
<https://dexcom.com/en-us/checkreceiver>
